Anatomical variation of maxillary sinus mimicking a periapical cyst: A case report

Basnet P¹, Kamath MP², Kundabala M³, Menda A⁴

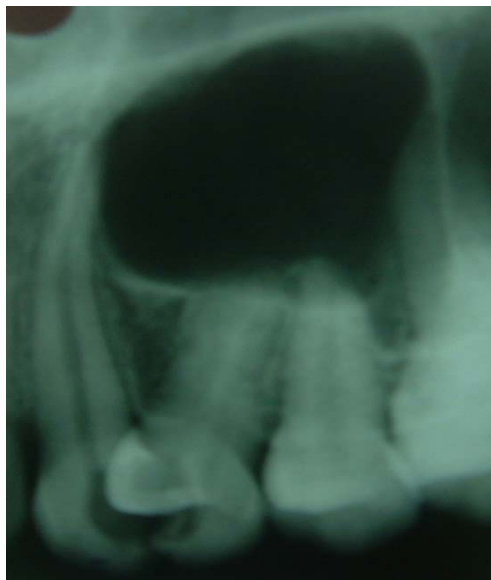
Fig. 1: Radiograph showing large well defined periapical radiolucency in relation to maxillary first molar, premolars extending to involve the root of canine which was suggestive of a periapical cyst.

A 19 year old female patient attended the Department of Conservative Dentistry and Endodontics, Manipal College of Dental Sciences, Mangalore, complaining of cavity in upper left canine with food getting stuck in that area. On clinical examination, caries was seen in distal aspect of left upper canine with no history of pain or trauma. On routine radiographic examination, a large well defined radiolucency was seen involving the root apices of upper left maxillary first molar, premolars and extending till the root apex of canine (shown in Fig. 1). On performance of vitality tests, all the teeth appeared to be vital.

In the present case, the radiographic examination of the lesion was suggestive of a cyst, because of its well defined border and the size of the lesion that was more than 10mm. For a cyst, according to Cotti et al⁹, Ultrasound examination shows a hypoechoic area with irregular border and no internal vascularization on Colour Power Doppler examination (shown in Fig. 4). However, in the present case, ultrasound examination showed a hyperechoic area with a dirty shadowing that is not typical of a cyst. This result made us go back to radiographic examination. Orthopentemogram was taken which revealed the outline of the maxillary sinus extending till the root of canine. Then combining the results from clinical examination, radiographic examinations, results from vitality tests and ultrasound examination, the final diagnosis was made which prevented the patient from undergoing inappropriate treatment. Therefore, a thorough knowledge about the anatomy and its variations, proper diagnostic aids and good interpretation skills are essential to come up with an accurate diagnosis.

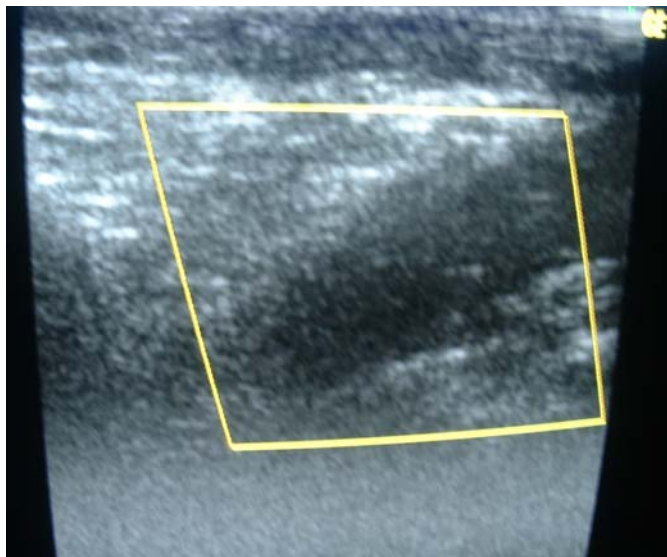
Fig. 2: Ultrasound and Colour Power Doppler indicating the same lesion as hyperechoic area with dirty shadowing suggestive of cavity filled with air.

Ultrasound with Colour Power Doppler examination revealed a hyperechoic area with irregular border and dirty shadowing within the lesion that was suggestive of a cavity filled with air (shown in Fig 2). After this an orthopantomogram was taken which revealed the maxillary sinus with its border extending to involve the root of canine, which is one of the anatomical variations of maxillary sinus (shown on Fig. 3).

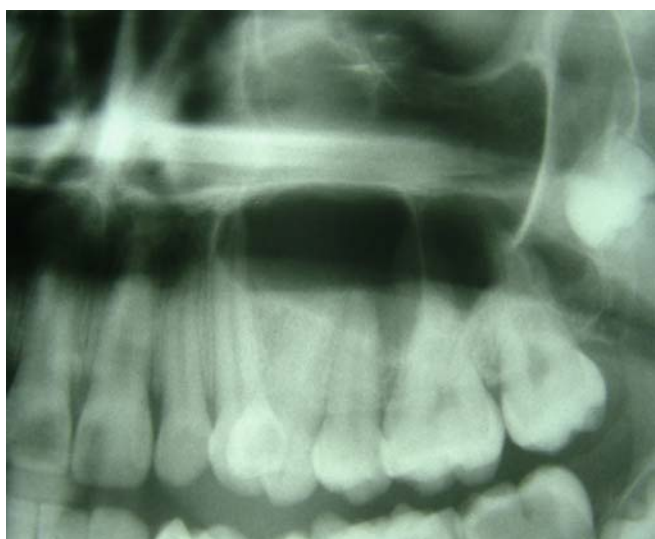
Fig. 3: Orthopentemogram showing the maxillary sinus extending from maxillary first molar till the root of canine.

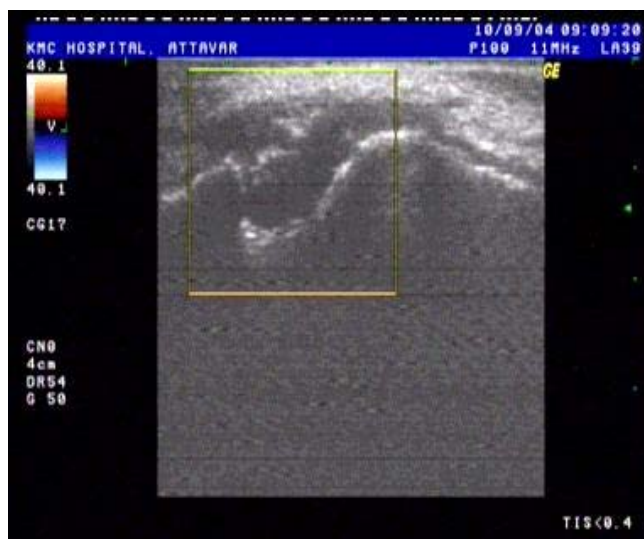
Fig. 4: Ultrasound and Colour Doppler showing Hypoechoic area with well defined border and no internal vascularity suggestive of Periapical Cyst

describing a cyst and a granuloma. For cystic lesion, a transonic or hypoechoic well-contoured cavity surrounded by reinforced bone walls filled with fluids and with no evidence of internal vascularization on application of Colour Power Doppler was observed. Whereas for granuloma, a poorly defined hypoechoic or Hyperechoic area exhibiting a vascular supply on application of Colour Power Doppler was observed.
